**Flood Control Project Maintenance
Levee Inspections**
LMA District Cover Sheet
Spring 2019 Levee Inspection Results

Reclamation District No. 0307 Lisbon

Spring 2019 Levee Inspection Results

Waterway			Bank	Unit Miles
Unit No. 01 Sacramento River			Right	6.56
	Spring (March - May)	Summer (June - August)	(September - November) Fall	Winter (December - February)
Unit Maintenance Rating (Fall Only)				
Date of Inspection	3/8/2019 - 3/8/2019			
DWR Inspector	Luz Dial			
Accompanied By	Pete Dwyer RD 307

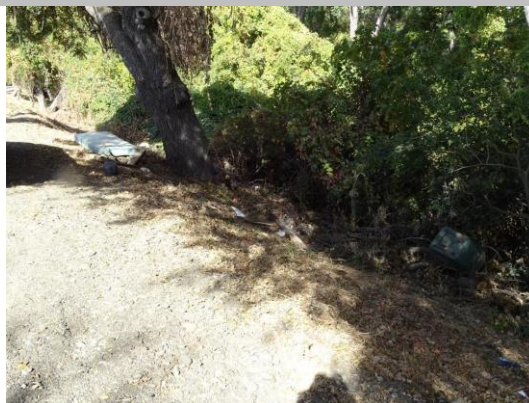
Photo 2 of 2 : SP_2019_RD0307_166_129_20190307_00040.jpg

View of mattress and other debris on slope. Fall 2018

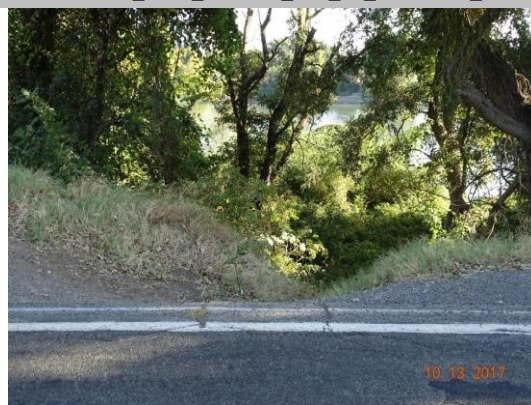
Photo 1 of 1 : SP_2019_RD0307_166_66_20190307_00016.jpg

LM Start	0.20	Rating **	M	Issue No.	66
LM End	0.20	Issue Type +	Ma	Location *	WS
Category	Earthen Levee			GPS Latitude/Longitude	
				Start	End
Item	Slope Stability			38.477977 °	38.477977 °
				-121.546914 °	-121.546914 °
DWR ID	DWR_RD0307_01_f_2017_66				
Comment Code					
S2 : Repair the levee slope damaged by foot traffic and prevent access where possible.					
Inspector Comment					
Foot traffic on waterside slope.

Slope erosion should be repaired and foot traffic stopped. Fall 2017

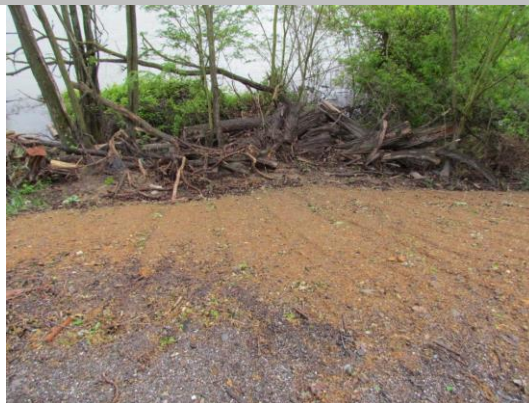
Photo 1 of 1 : SP_2019_RD0307_166_62_20190307_00015.jpg

RD 307 Levee mile 0.35 water side levee slope fallen cut up tree branches and tree sections placed at levee toe.

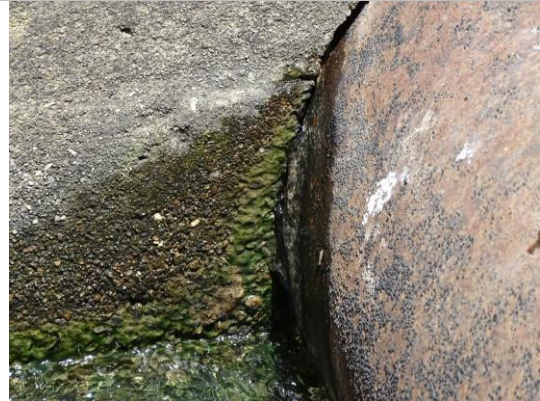
Photo 1 of 3 : UCIP_SP_2019_53336_77562.jpg

FS_ID:53336
DS_ID:21657
EP_NO: N/A
Repair Type: Urgent
Crossing Status: Found
UCIP Comments: 06/05/2018 Same as last inspection, except the LS (sleeved) pipe at the concrete wall was grouted. WS pipe outlet shows leakage from outside the pipe; concern for erosion around pipe and within the levee. This crossing remains Urgent and recommend this crossing receive a thorough inspection by the owner (D. Sanoski - DWR UCIP)12/07/2016 Same as last inspection. The bottom portion of the pipe has several holes through the wall. Recommend owner stop use of crossing. Owner will need to coordinate with CVFPB to comply with Title 23 requirements. (O. Magana - DWR UCIP)07/31/2013 Pipe heavily corroded and will likely need replacement if 15-inch pipe sleeved through it needs replacement. Annular space not grouted between two pipes. (W. Wylie - DWR UCIP)
FIELD_STRUCT_DESC: 15-inch steel irrigation pipe through the levee, 16.7 feet below the crown. 15-inch pipe sleeved through an existing 20-inch pipe. 20-inch pipe first recorded in the 1964 USACE O&M Manual. Pump missing from abandoned steel pier located on the waterside (WS) toe. Walkway on the waterside (WS) from shoulder to pier missing or abandoned. Concrete U-shaped outlet with flap gate is located on the landside (LS) toe. Service pole located on the LS slope with anchor. [Additional Reference(s): DWR Levee Log, 1990. USACE Sacramento O&M Manual Unit 114, October 1964, (River Mile 48.53)].

LS view: pipe on LS showing leak; potential for internal threat to levee.

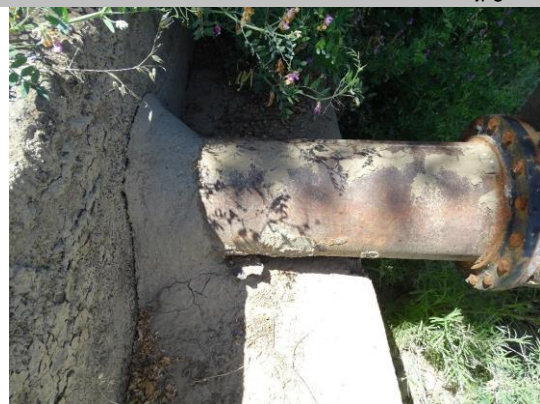
Photo 2 of 3 : UCIP_SP_2019_53336_77563.jpg

WS view: grouted sleeved pipe.

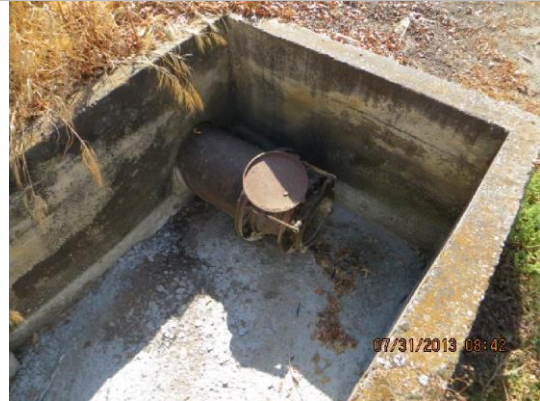
Photo 3 of 3 : UCIP_SP_2019_53336_28732.jpg

Comment Code						
Inspector Comment						
FS_ID:53336 DS_ID:21657 EP_NO: N/A Repair Type: Urgent Crossing Status: Found UCIP Comments: 06/05/2018 Same as last inspection, except the LS (sleeved) pipe at the concrete wall was grouted. WS pipe outlet shows leakage from outside the pipe; concern for erosion around pipe and within the levee. This crossing remains Urgent and recommend this crossing receive a thorough inspection by the owner (D. Sanoski - DWR UCIP)12/07/2016 Same as last inspection. The bottom portion of the pipe has several holes through the wall. Recommend owner stop use of crossing. Owner will need to coordinate with CVFPB to comply with Title 23 requirements. (O. Magana - DWR UCIP)07/31/2013 Pipe heavily corroded and will likely need replacement if 15-inch pipe sleeved through it needs replacement. Annular space not grouted between two pipes. (W. Wylie - DWR UCIP) FIELD_STRUCT_DESC: 15-inch steel irrigation pipe through the levee, 16.7 feet below the crown. 15-inch pipe sleeved through an existing 20-inch pipe. 20-inch pipe first recorded in the 1964 USACE O&M Manual. Pump missing from abandoned steel pier located on the waterside (WS) toe. Walkway on the waterside (WS) from shoulder to pier missing or abandoned. Concrete U-shaped outlet with flap gate is located on the landside (LS) toe. Service pole located on the LS slope with anchor. [Additional Reference(s): DWR Levee Log, 1990. USACE Sacramento O&M Manual Unit 114, October 1964, (River Mile 48.53)]. FS Date: 6/5/2018 10:02:00 AM

Pipe at outlet on LS toe.

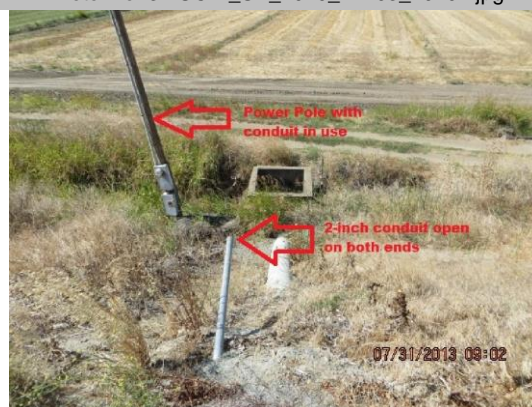
Photo 1 of 3 : UCIP_SP_2019_17103_29202.jpg

LM Start	0.93	Rating **	M	Issue No.	162
LM End	0.93	Issue Type +	En	Location *	
Category	Supplemental			GPS Latitude/Longitude	
				Start	End
Item	DWR UCIP Field Study			38.472872 °	38.472872 °
				-121.535542 °	-121.535542 °
DWR ID	24014				
Comment Code					
Inspector Comment					
FS_ID:17103 DS_ID:24014 EP_NO: 18229 Repair Type: Non-Urgent Crossing Status: Found UCIP Comments: Pipe open on both ends. Need to install caps. FIELD_STRUCT_DESC: 2 of 2: 2-inch galvanized iron electrical conduit through the levee, 2 feet below the crown. (Permit No. 18229, 2007 - Albert Martinelli). FS Date: 7/31/2013

Conduit visible 2-feet below the crown on the LS shoulder.

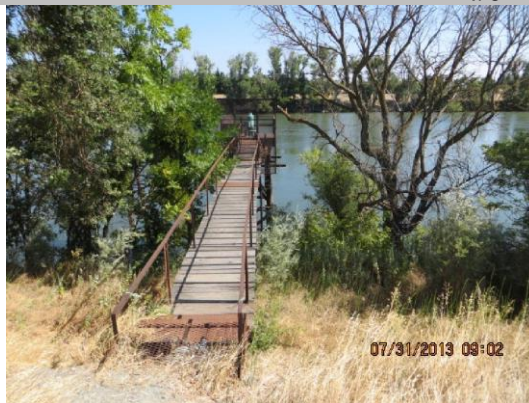
Photo 2 of 3 : UCIP_SP_2019_17103_29201.jpg

Conduit visible under first step of walkway to pump on WS shoulder.

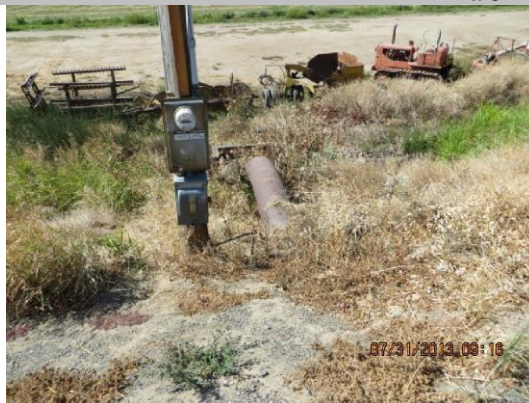
Photo 1 of 3 : UCIP_SP_2019_16764_28764.jpg

Comment Code					
Inspector Comment					
FS_ID:16764 DS_ID:21659 EP_NO: 8012 Repair Type: Non-Urgent Crossing Status: Found UCIP Comments: Pipe rusted through at outlet on LS of shutoff valve. This may be good indicator or corrosion throughout pipe. This is a good candidate for video inspection. FIELD_STRUCT_DESC: 1 of 2: 20-inch steel irrigation pipe through the levee, 7.4 feet below the crown. Walkway from the waterside (WS) shoulder to pump on pile structure in stream. Distribution box and gate valve at the landside (LS) toe. Service pole on the LS. (Permit No. 8012, 1972 - Eula Glide Elliott). [Additional Reference(s): DWR Levee Log, 1990. USACE Sacramento O&M Manual 114, April 1959, (RM 48.53)]. FS Date: 7/31/2013

Pipe and JP/meter on LS slope.

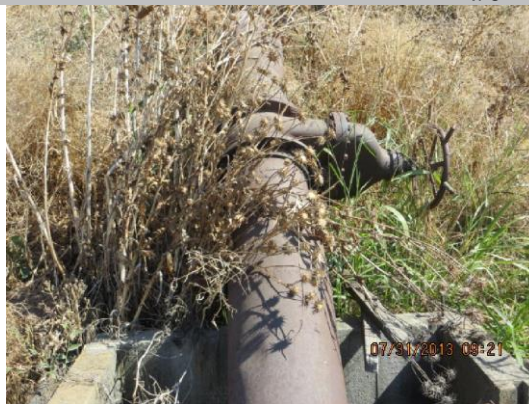
Photo 2 of 3 : UCIP_SP_2019_16764_28763.jpg

Pipe, gate valve, and concrete distribution box on LS toe.

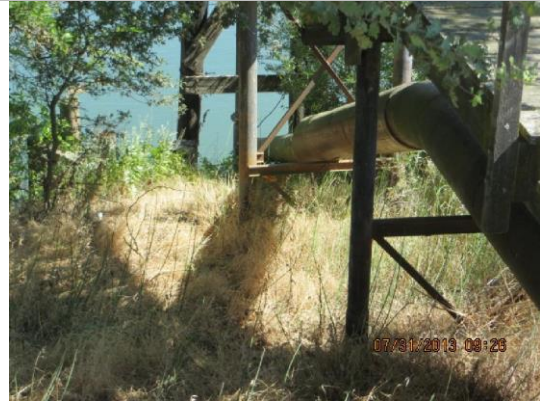
Photo 3 of 3 : UCIP_SP_2019_16764_28762.jpg

Comment Code						
Inspector Comment						
FS_ID:16764 DS_ID:21659 EP_NO: 8012 Repair Type: Non-Urgent Crossing Status: Found UCIP Comments: Pipe rusted through at outlet on LS of shutoff valve. This may be good indicator or corrosion throughout pipe. This is a good candidate for video inspection. FIELD_STRUCT_DESC: 1 of 2: 20-inch steel irrigation pipe through the levee, 7.4 feet below the crown. Walkway from the waterside (WS) shoulder to pump on pile structure in stream. Distribution box and gate valve at the landside (LS) toe. Service pole on the LS. (Permit No. 8012, 1972 - Eula Glide Elliott). [Additional Reference(s): DWR Levee Log, 1990. USACE Sacramento O&M Manual 114, April 1959, (RM 48.53)]. FS Date: 7/31/2013

Pipe visible under wooden walkway on WS slope.

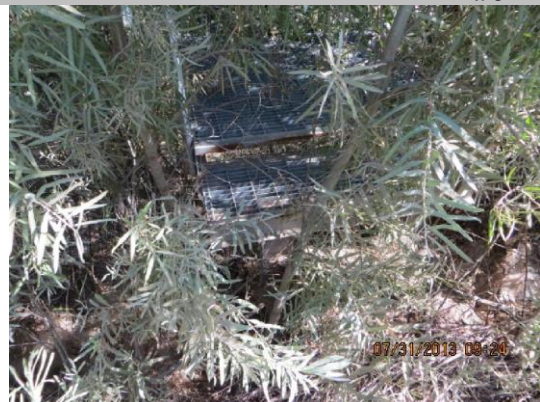
Photo 1 of 3 : UCIP_SP_2019_16766_28769.jpg

LM Start	1.08	Rating **	M	Issue No.	164
LM End	1.08	Issue Type +	En	Location *	
Category	Supplemental			GPS Latitude/Longitude	
				Start	End
Item	DWR UCIP Field Study			38.472874 °	38.472874 °
				-121.532611 °	-121.532611 °
DWR ID	21660				
Comment Code					
Inspector Comment					
FS_ID:16766 DS_ID:21660 EP_NO: 3324 Repair Type: Non-Urgent Crossing Status: Found UCIP Comments: Walkway completely obscured by vegetation on WS slope. FIELD_STRUCT_DESC: 1.25-inch electrical conduit of an unknown material through the levee, 10 feet below the crown. Corrugated metal stage recorder house and walkway on the waterside (WS) slope. Service pole on the landside (LS) slope. (Permit No. 3324, 1960 - U.S. Department of the Interior, Surface Water Branch). [Additional Reference(s): DWR Levee Log, 1990]. FS Date: 7/31/2013

Metal walkway visible in brush on WS slope.

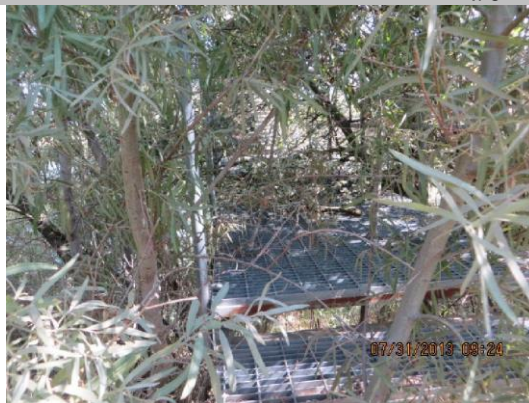
Photo 2 of 3 : UCIP_SP_2019_16766_28768.jpg

Metal walkway visible in brush on WS slope.

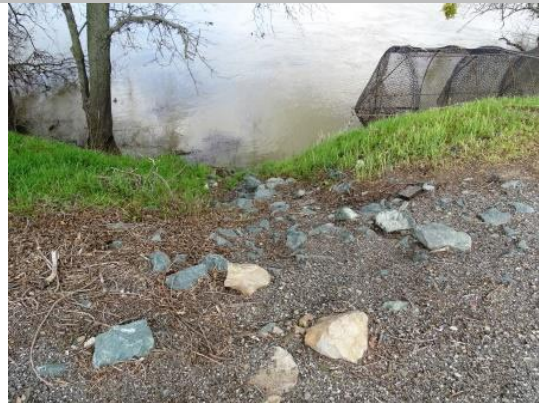
Photo 1 of 1 : SP_2019_RD0307_166_44_20190312_00135.jpg

LM Start	1.14	Rating **	M	Issue No.	44
LM End	1.23	Issue Type +	Ma	Location *	WS
Category	Supplemental			GPS Latitude/Longitude	
				Start	End
Item	2017 USACE Erosion Survey, DRAFT			38.473161 °	38.473103 °
				-121.531474 °	-121.529831 °
DWR ID	DWR_RD0307_01_s_2019_44				
Comment Code					
Inspector Comment					
2017 Site ID: SAC 48.6 R					
Status: Eroding					
2017 Field Notes: Site lengthened upstream and shortened downstream.					
Site History: 2012 - Bank is slowly eroding, old rock protection starting to unravel. 2016 - Anthropogenic erosion observed.					
2019 DWR Spring Inspection: Riprap placed on worst location.

View of revetment on worst location of erosion. Spring 2019

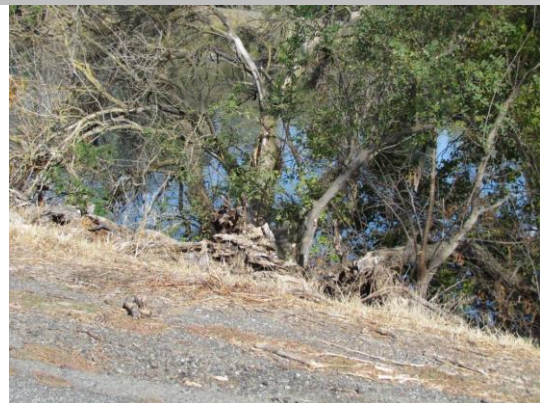
Photo 1 of 1 : SP_2019_RD0307_166_10_20190307_00002.jpg

Remove unwanted trees from waterside slope. These trees are dead and are resting on the slope. No change 4-17.

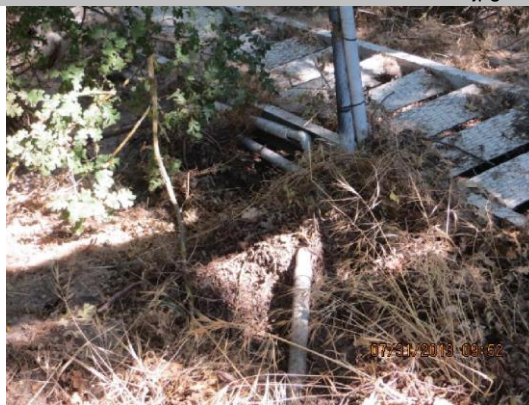
Photo 2 of 3 : UCIP_SP_2019_17105_29206.jpg

LM Start	1.62	Rating **	M	Issue No.	165
LM End	1.62	Issue Type +	En	Location *	
Category	Supplemental			GPS Latitude/Longitude	
				Start	End
Item	DWR UCIP Field Study			38.473129 °	38.473129 °
				-121.522717 °	-121.522717 °
DWR ID	24017				
Comment Code					
Inspector Comment					
FS_ID:17105 DS_ID:24017 EP_NO: N/A Repair Type: Non-Urgent Crossing Status: Found UCIP Comments: No permit identified for crossing or boat dock/steel ramp. FIELD_STRUCT_DESC: 2 of 2: 1.5-inch polyvinyl chloride (PVC) irrigation pipe through the levee, 2 feet below the crown. Metal walkway and pier on the waterside (WS) slope. Possible pump, filter, and tanks on the landside (LS) slope. FS Date: 7/31/2013

Pipes visible on WS shoulder at steel walkway.

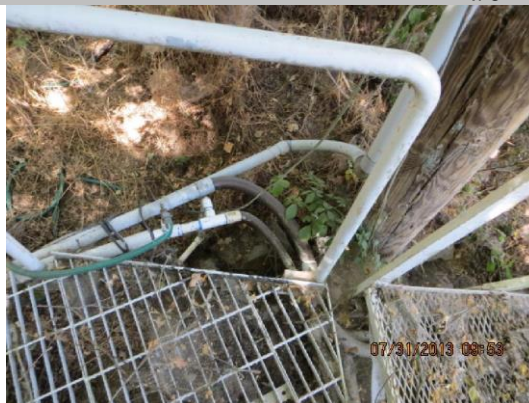
Photo 3 of 3 : UCIP_SP_2019_17105_29205.jpg

Pipes visible under walkway on WS slope.

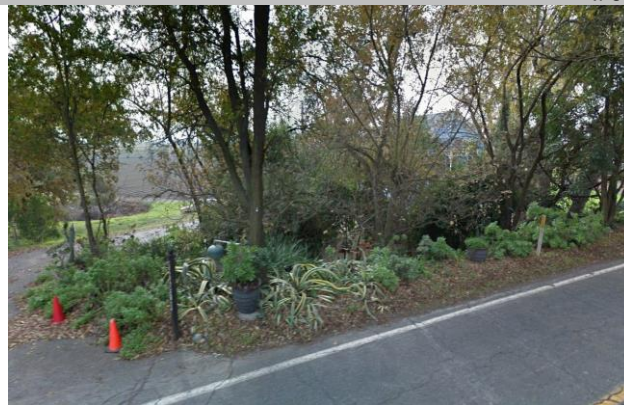
Photo 1 of 1 : SP_2019_RD0307_166_84_20190307_00023.jpg

LM Start	1.62	Rating **	U	Issue No.	84
LM End	1.62	Issue Type +	En	Location *	LS
Category	Earthen Levee			GPS Latitude/Longitude	
				Start	End
Item	Vegetation			38.473116 °	38.473116 °
				-121.522713 °	-121.522713 °
DWR ID	DWR_RD0307_01_f_2017_84				
Comment Code					
V6 : Landscaping					
Inspector Comment

10/13/2017: Landscaping, including structures, should be removed or maintained to allow inspection and access to slope, toe and 10-foot easement.

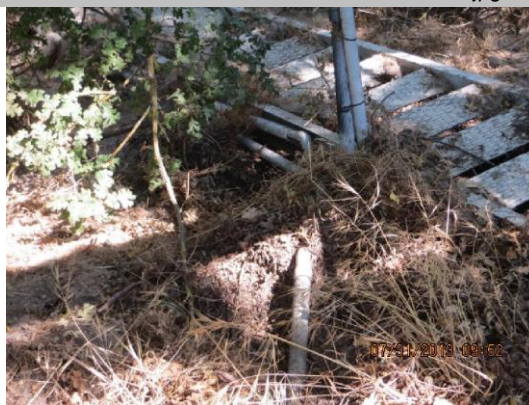
Photo 2 of 3 : UCIP_SP_2019_17106_29209.jpg

LM Start	1.62	Rating **	M	Issue No.	166	
LM End	1.62	Issue Type +	En	Location *		
Category	Supplemental			GPS Latitude/Longitude		
				Start	End	
Item	DWR UCIP Field Study			38.473129 °	38.473129 °	
				-121.522717 °	-121.522717 °	
DWR ID	24016					
Comment Code						
Inspector Comment						
FS_ID:17106						
DS_ID:24016						
EP_NO: N/A						
Repair Type: Non-Urgent						
Crossing Status: Found						
UCIP Comments: No permit identified for this crossing.						
FIELD_STRUCT_DESC: 1 of 2: 1.5-inch polyvinyl chloride (PVC)						
irrigation pipe through the levee, 2 feet below the crown. Metal walkway						
and pier on the waterside (WS) slope. Possible pump, filter, and tanks						
on the landside (LS) slope.						
FS Date: 7/31/2013

Pipes visible on WS shoulder at metal ramp.

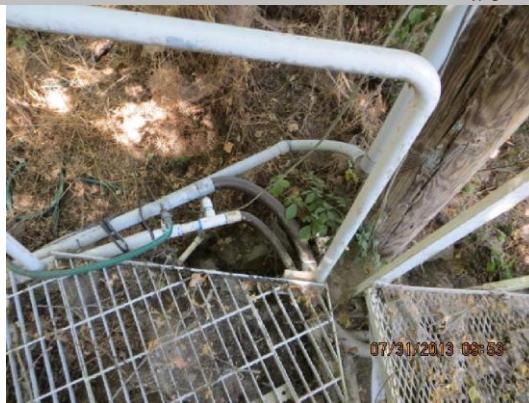
Photo 3 of 3 : UCIP_SP_2019_17106_29208.jpg

Pipes visible under metal ramp on WS slope.

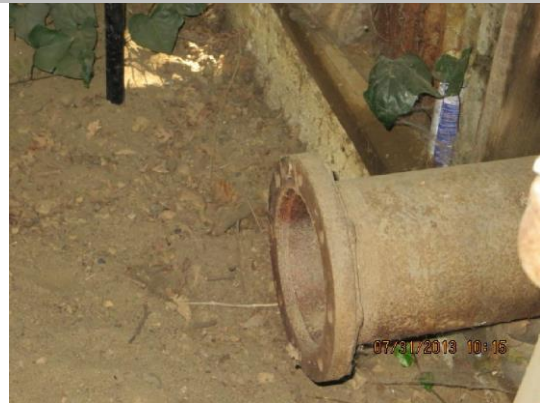
Photo 1 of 2 : UCIP_SP_2019_16805_28806.jpg

Comment Code					
Inspector Comment					
FS_ID:16805 DS_ID:21663 EP_NO: 8016 Repair Type: Non-Urgent Crossing Status: Indicator Found UCIP Comments: Needs to be abandoned properly. FIELD_STRUCT_DESC: *ABANDONED* 8-inch iron irrigation pipe through the levee, 15.7 feet below the crown. No connection in pump house on the landside (LS) toe, but 8-inch outlet pipe remains at connection from pump house to concrete standpipe. (Permit No. 8016, 1972 - Anna Gloria Serpa. Pipe capped at both ends for replacement pipe according to Permit No. 18209, 2007 - Daniel Serpa). [Additional Reference(s): DWR Levee Log, 1990. USACE Sacramento O&M Manual 114, April 1959, (RM 47.78)]. FS Date: 7/31/2013

Remnants of abandoned pipe visible in pumphouse on LS toe.

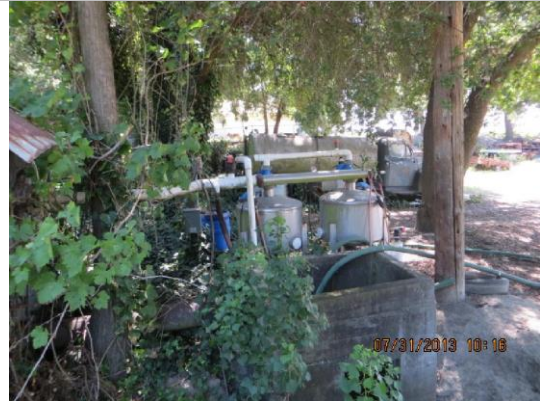
Photo 2 of 2 : UCIP_SP_2019_16805_28805.jpg

Concrete distribution box at LS toe.

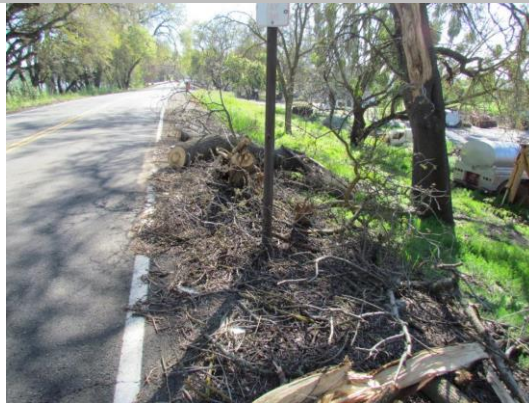
Photo 2 of 3 : SP_2019_RD0307_166_73_20190307_00018.jpg

Looking downstream toward levee mile 1.87 fallen tree on shoulder.

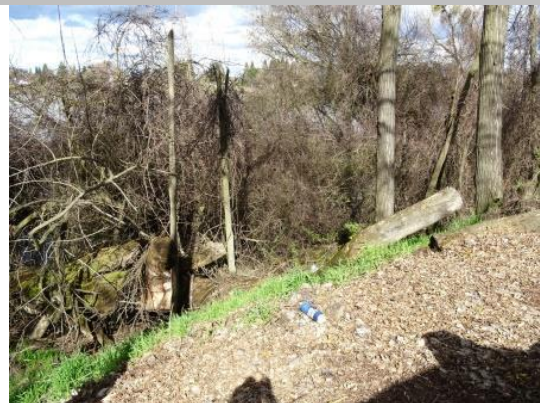
Photo 1 of 1 : SP_2019_RD0307_166_150_20190312_00133.jpg

View of fallen tree on levee slope. Spring 2019

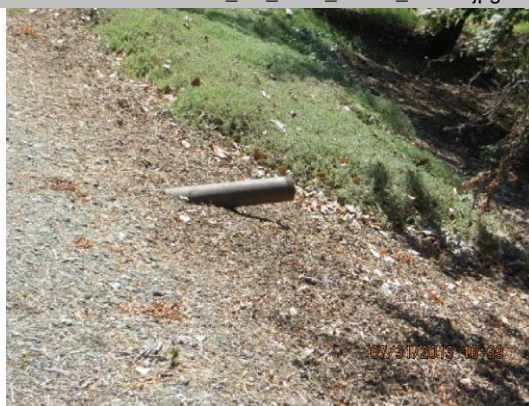
Photo 1 of 3 : UCIP_SP_2019_22709_38412.jpg

Pipe visible on LS shoulder.

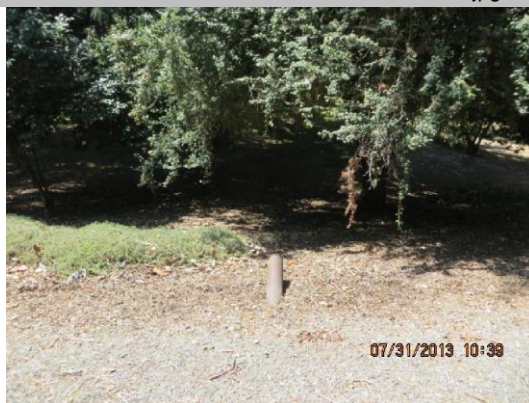
Photo 2 of 3 : UCIP_SP_2019_22709_38411.jpg

Pipe visible on LS shoulder.

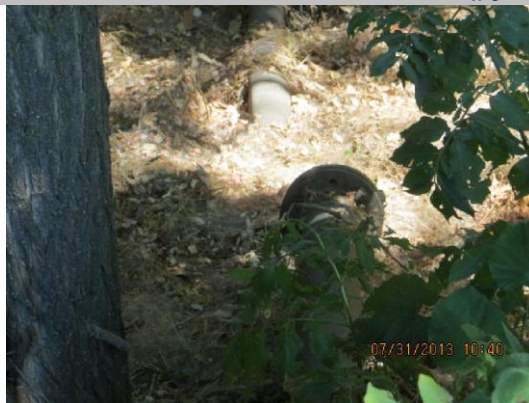
Photo 3 of 3 : UCIP_SP_2019_22709_38410.jpg

Pipe visible on WS slope.

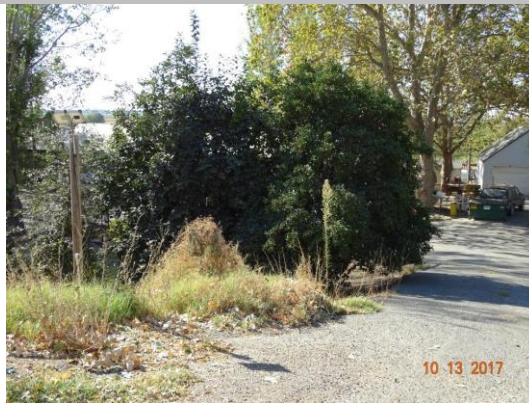
Photo 1 of 1 : SP_2019_RD0307_166_92_20190307_00024.jpg

Remove fruit trees on levee slope. Fall 2017

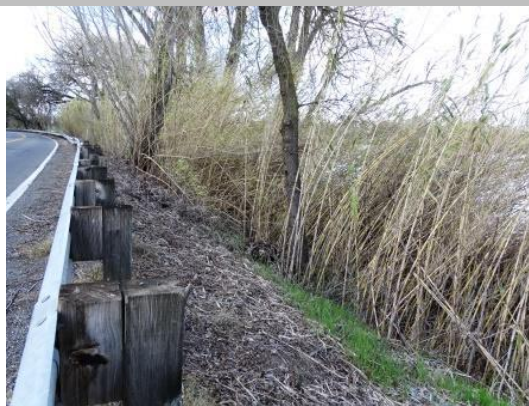
Photo 1 of 1 : SP_2019_RD0307_166_88_20190312_00131.jpg

View of Arundo on levee slope. Spring 2019

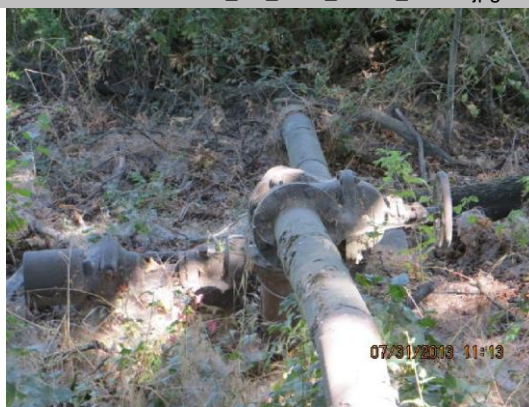
Photo 2 of 3 : UCIP_SP_2019_40794_28822.jpg

Pump and gate valve on WS slope.

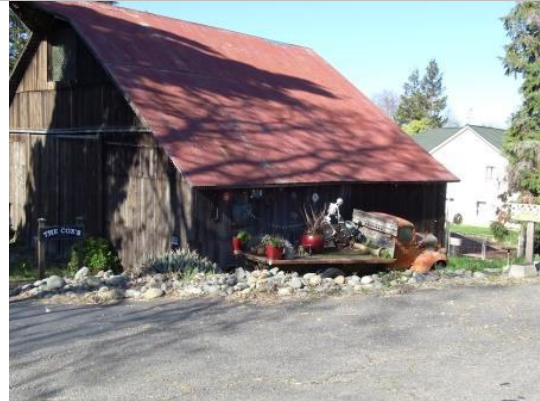
Photo 1 of 1 : SP_2019_RD0307_166_89_20190312_00121.jpg

View of decorative abandoned vehicle on levee toe. Spring 2019

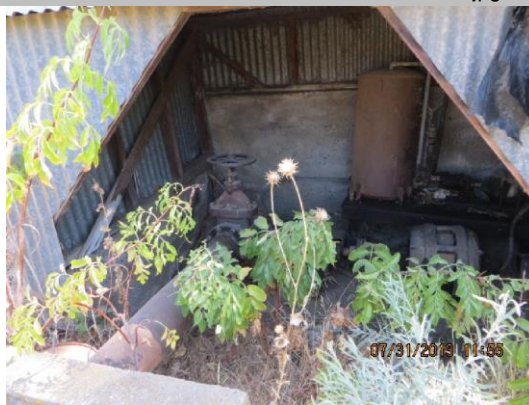
Photo 2 of 2 : UCIP_SP_2019_16815_28849.jpg

Pump and gate valve inside pumphouse on LS toe.

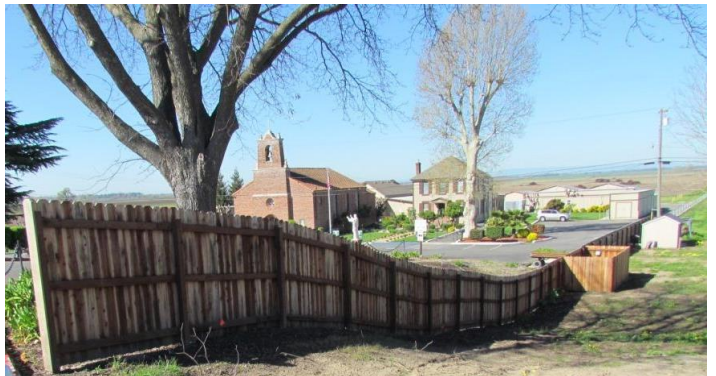
Photo 1 of 1 : SP_2019_RD0307_166_79_20190307_00021.jpg

Looking down the landside slope and shoulder of levee mile 3.19 new replacement of a solid wall wooden fence.

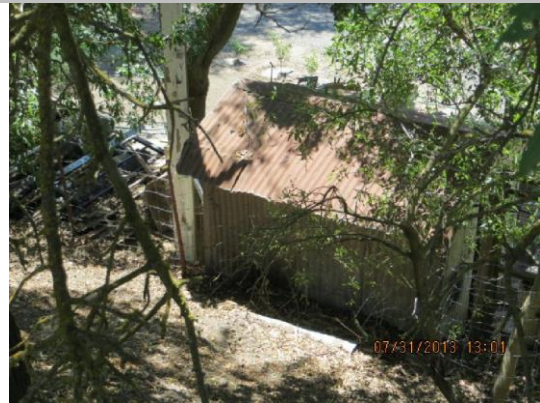
Photo 1 of 2 : UCIP_SP_2019_16843_28881.jpg

Pumphouse on LS toe. No access due to fence along toe.

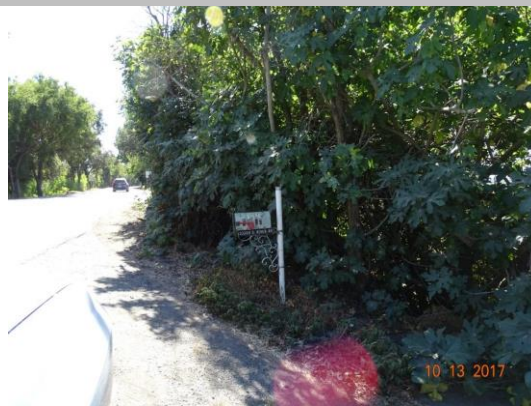
Photo 1 of 1 : SP_2019_RD0307_166_23_20190307_00003.jpg

Remove the fig tree from the landside levee slope. Fall 2017

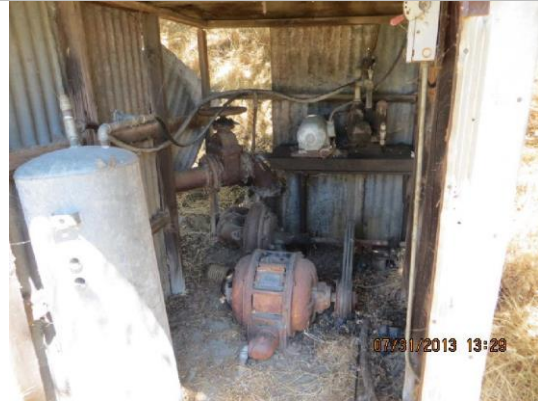
Photo 3 of 3 : UCIP_SP_2019_16923_28976.jpg

Gate valve and pump in pumphouse on LS toe.

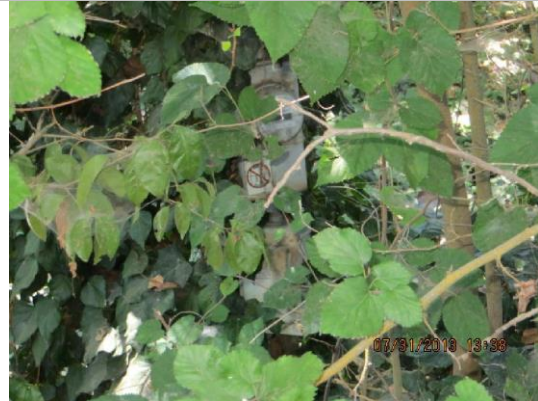
Photo 3 of 3 : UCIP_SP_2019_16924_28980.jpg

Meter on JP at LS toe covered with vegetation/IVY.

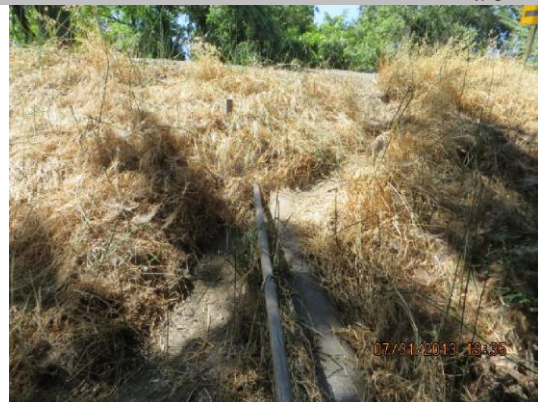
Photo 1 of 2 : UCIP_SP_2019_16925_28984.jpg

Conduit visible on WS slope.

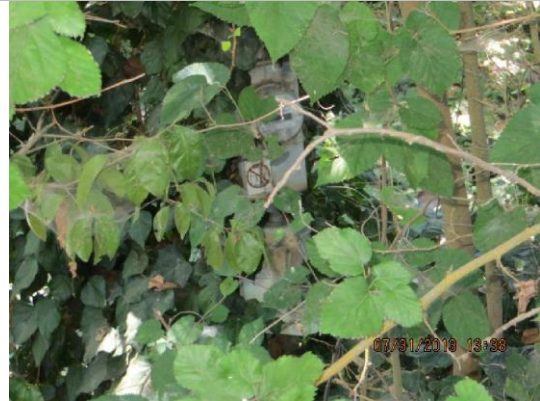
Photo 2 of 2 : UCIP_SP_2019_16925_28983.jpg

JP and meter on LS toe.

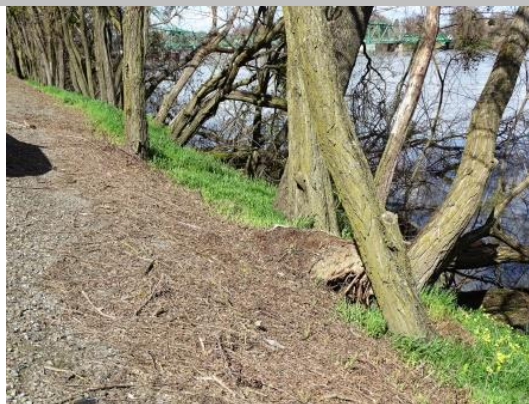
Photo 1 of 1 : SP_2019_RD0307_166_142_20190312_00124.jpg

View of fallen tree with rootball exposed. Spring 2019

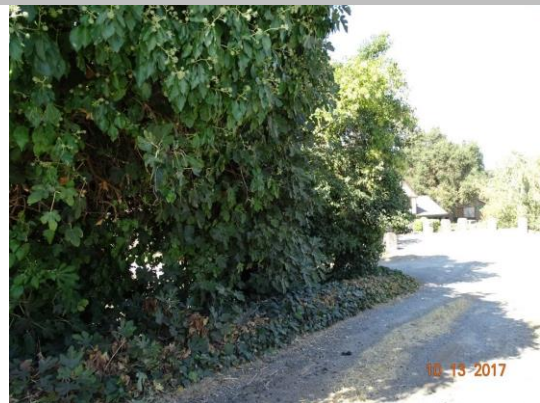
Photo 1 of 1 : SP_2019_RD0307_166_109_20190307_00032.jpg

Trim and thin landscaping to allow inspection and access to landside levee slope and toe. Fall 2017

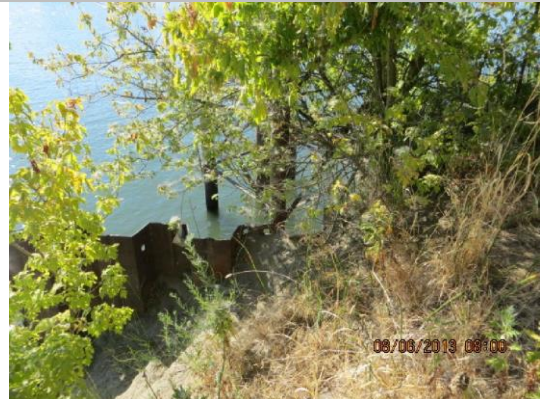
Photo 2 of 3 : UCIP_SP_2019_53338_29021.jpg

Sheet pile wall at WS toe.

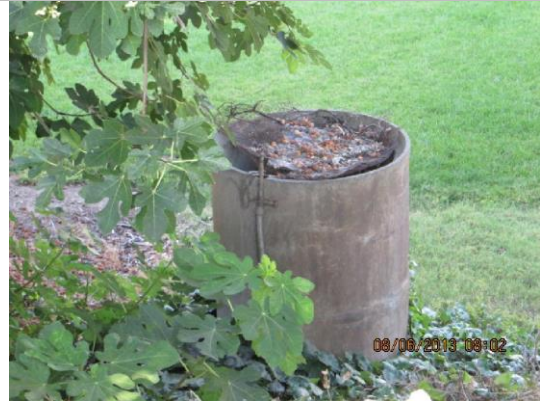
Photo 3 of 3 : UCIP_SP_2019_53338_29020.jpg

48-inch concrete standpipe on LS toe.

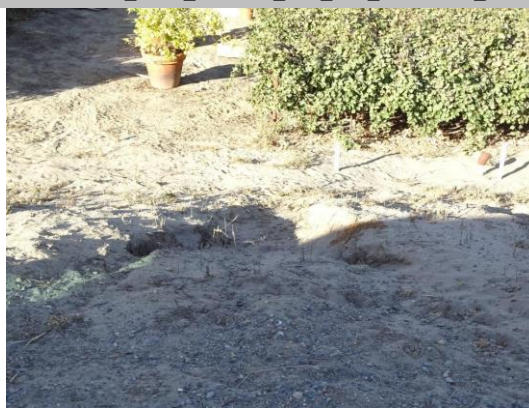
Photo 1 of 3 : SP_2019_RD0307_166_128_20190307_00036.jpg

View of erosion on slope. Fall 2018

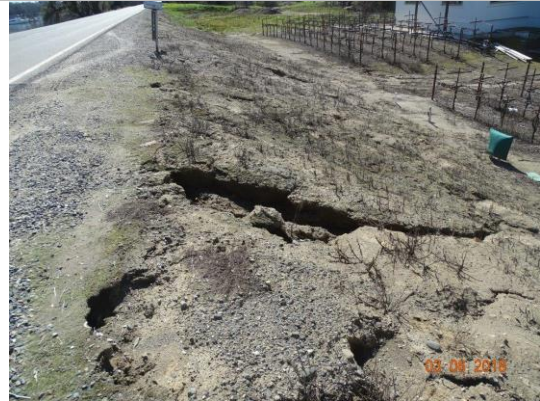
Photo 3 of 3 : SP_2019_RD0307_166_128_20190307_00038.jpg

Erosion rodent hole landside looking south. Spring 2018

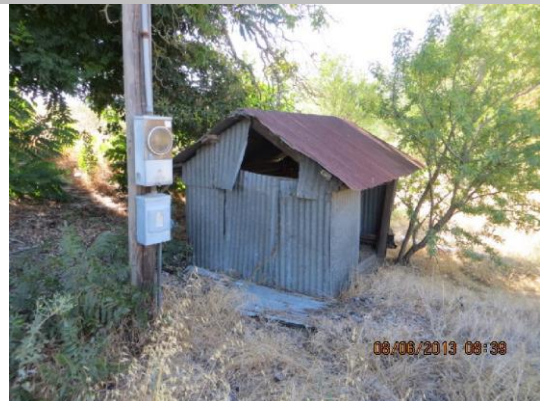
Photo 2 of 3 : UCIP_SP_2019_53339_29260.jpg

Power Pole, meter, and pumphouse on LS toe.

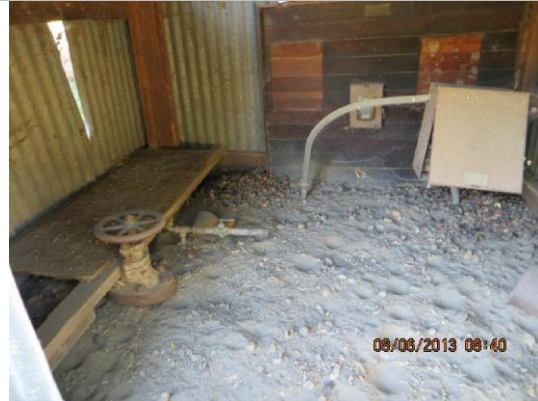
Photo 3 of 3 : UCIP_SP_2019_53339_29259.jpg

Gate valve in pumphouse on LS toe. pumphouse filled with soil.

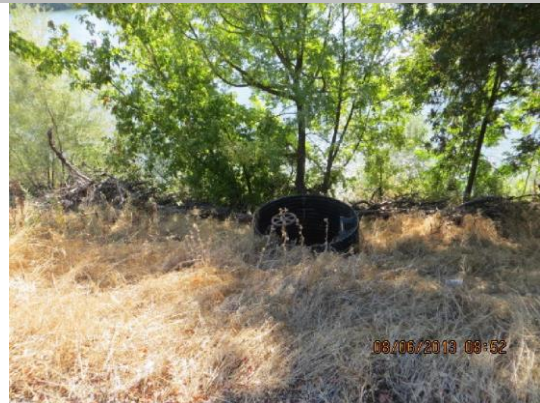
Photo 1 of 3 : UCIP_SP_2019_22670_38290.jpg

Slide gate in riser on WS slope.

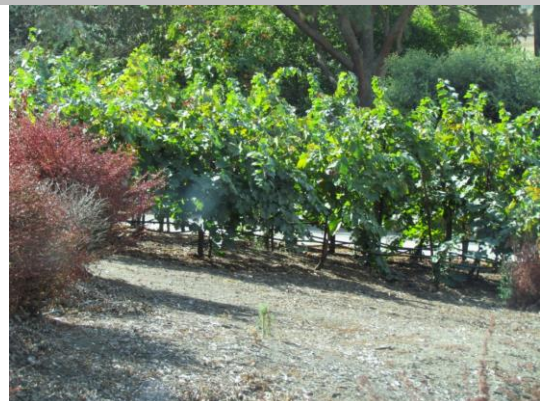
Photo 1 of 1 : SP_2019_RD0307_166_27_20190307_00006.jpg

Grapes placed on levee slope, these grapes have been reported to both district and CVFPB. No permit.

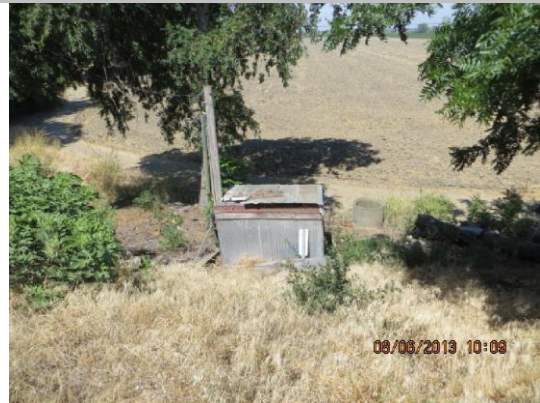
Photo 1 of 3 : UCIP_SP_2019_17183_29321.jpg

Pumphouse for 6-inch pipe at LS toe.

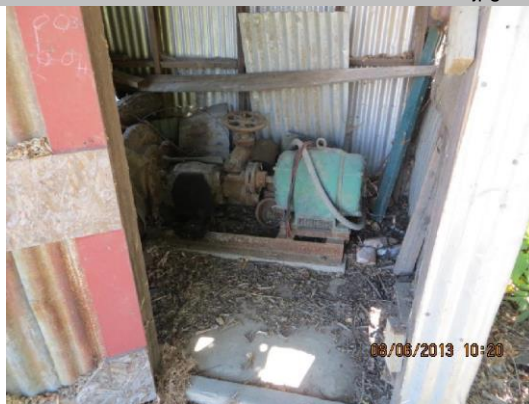
Photo 3 of 3 : UCIP_SP_2019_17183_29323.jpg

Pump in pumphouse on LS toe.

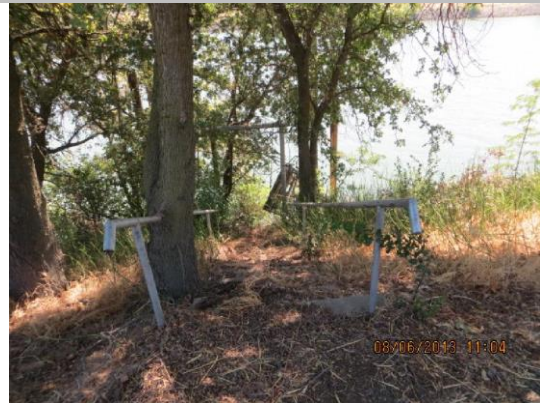
Photo 1 of 3 : UCIP_SP_2019_17184_29326.jpg

Pipe and gate valve on WS slope just downstream from stairs.

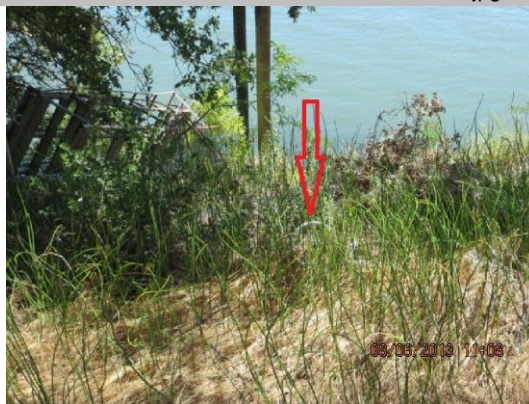
Photo 3 of 3 : UCIP_SP_2019_17184_29324.jpg

Gate valve actuator on WS slope.

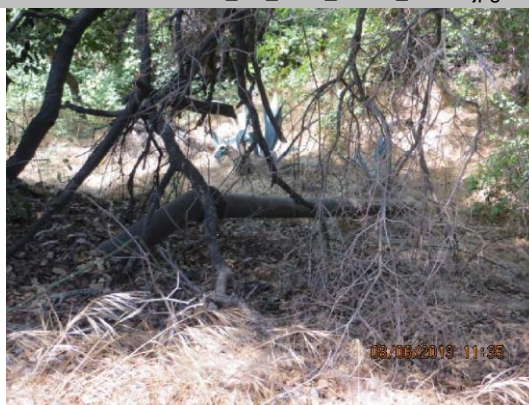
Photo 1 of 1 : UCIP_SP_2019_22671_38293.jpg

Pipe visible on LS slope.

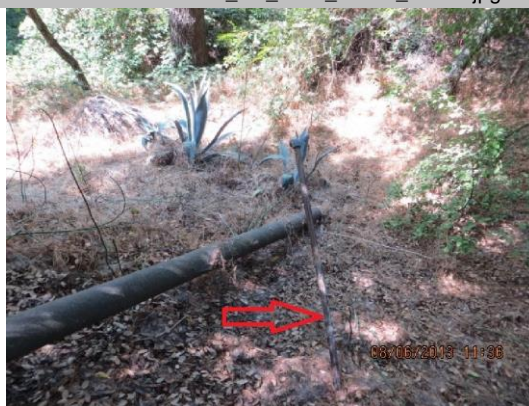
Photo 1 of 1 : UCIP_SP_2019_22672_38296.jpg

Abandoned electrical conduit next to pipe on LS slope.

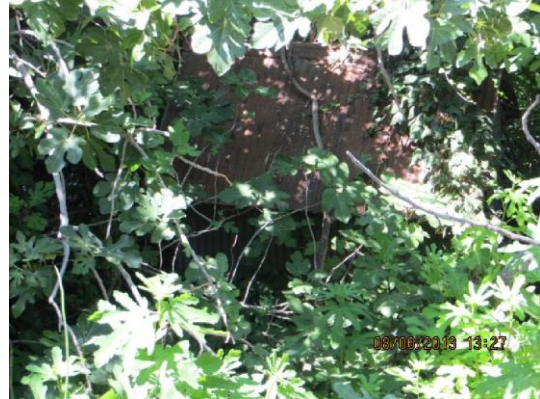
Photo 3 of 3 : UCIP_SP_2019_22710_38413.jpg

Pumphouse on LS toe.

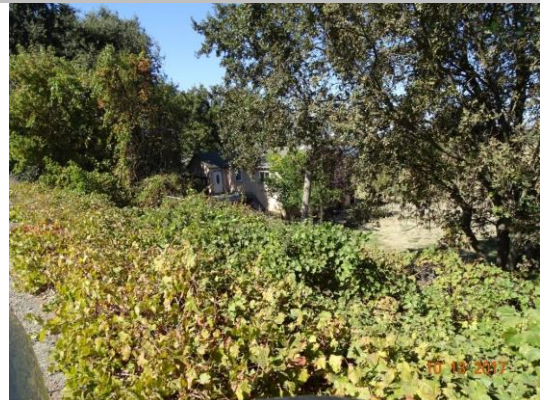
Photo 1 of 1 : SP_2019_RD0307_166_121_20190307_00035.jpg

Trim and thin landscaping to allow inspection and access to landside levee slope and toe.

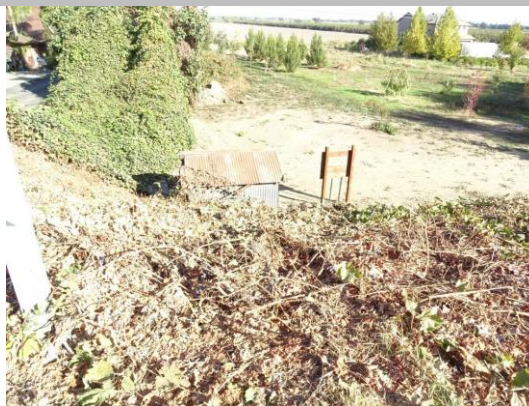
Photo 1 of 1 : SP_2019_RD0307_166_58_20190307_00012.jpg

View of shed at levee toe. Fall 2018

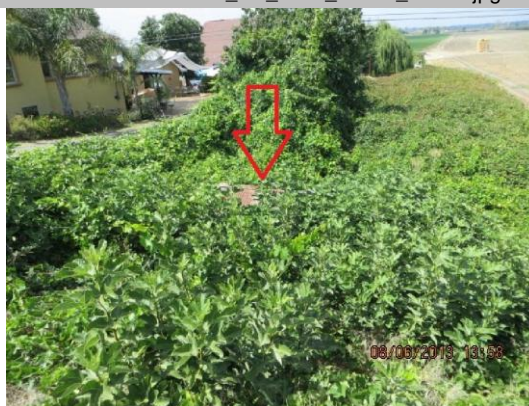
Photo 1 of 2 : UCIP_SP_2019_40546_29421.jpg

Pumphouse on LS toe.

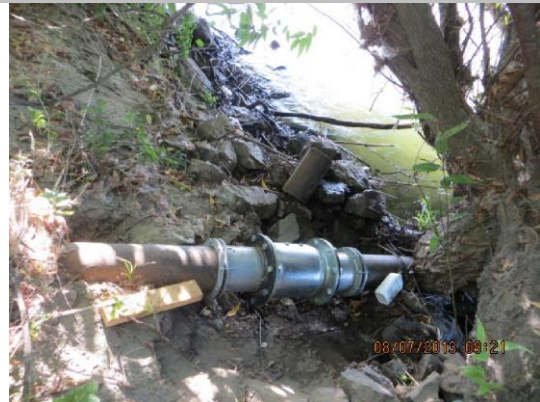
Photo 3 of 3 : UCIP_SP_2019_17287_29425.jpg

Pipe visible at WS toe.

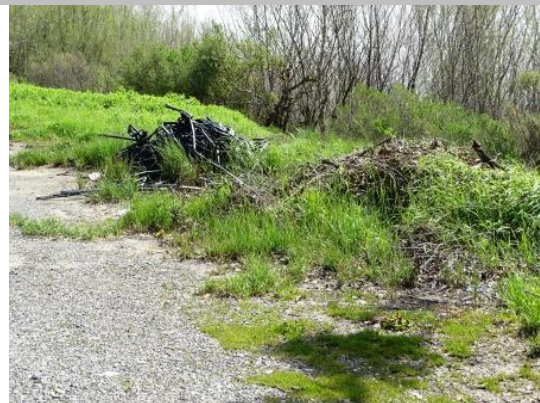
Photo 1 of 1 : SP_2019_RD0307_166_135_20190312_00122.jpg

View of landscaping debris and prunings dumped on waterside slope.
Spring 2019

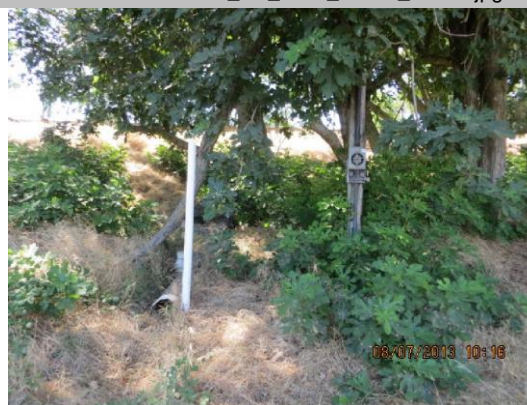
Photo 1 of 2 : UCIP_SP_2019_22711_38419.jpg

Power pole and meter off LS toe.

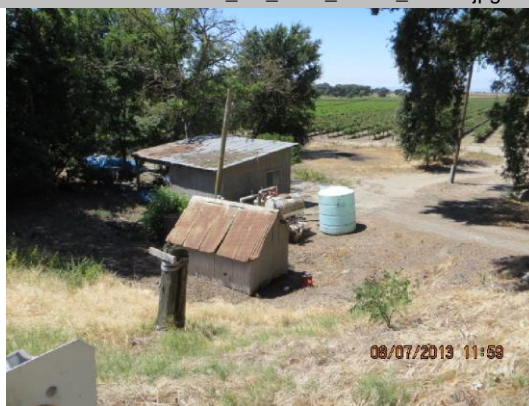
Photo 1 of 3 : UCIP_SP_2019_17385_29489.jpg

Pump and gate valve inside pumphouse on LS toe.

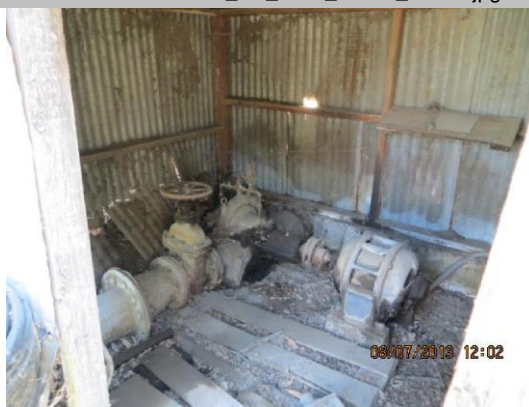
Photo 2 of 3 : UCIP_SP_2019_17385_29488.jpg

Pump and gate valve inside pumphouse on LS toe.

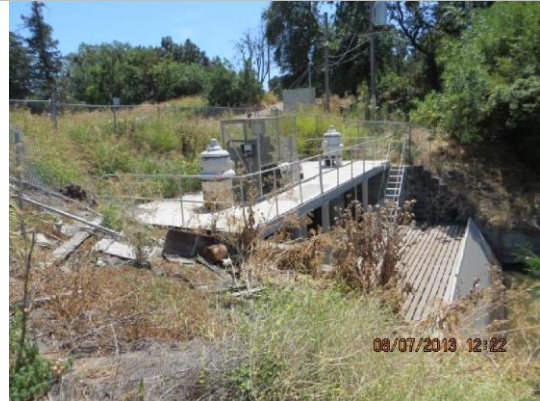
Photo 3 of 3 : UCIP_SP_2019_17404_29502.jpg

Pumping plant and trash rack off LS toe.

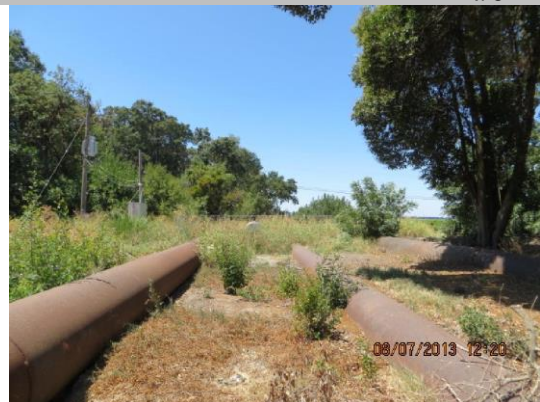
Photo 1 of 3 : UCIP_SP_2019_17406_29510.jpg

Pipes visible on LS toe.

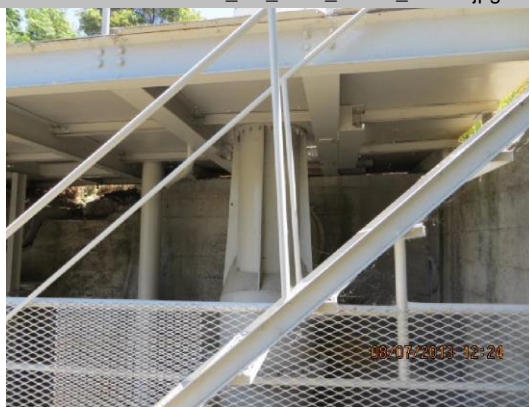
Photo 3 of 3 : UCIP_SP_2019_17406_29508.jpg

Intake at concrete headwall under pump.
